UNITED STATES ENVIRONMENTAL PROTECTION AGENCY

SUBJ: EPA Asbestos Removal at 233 Eden Street

REMOVAL ACTION STATUS REPORT DAVIDSON ASBESTOS

Property Address: 233 Eden Street, Davidson, Mecklenburg County, North Carolina

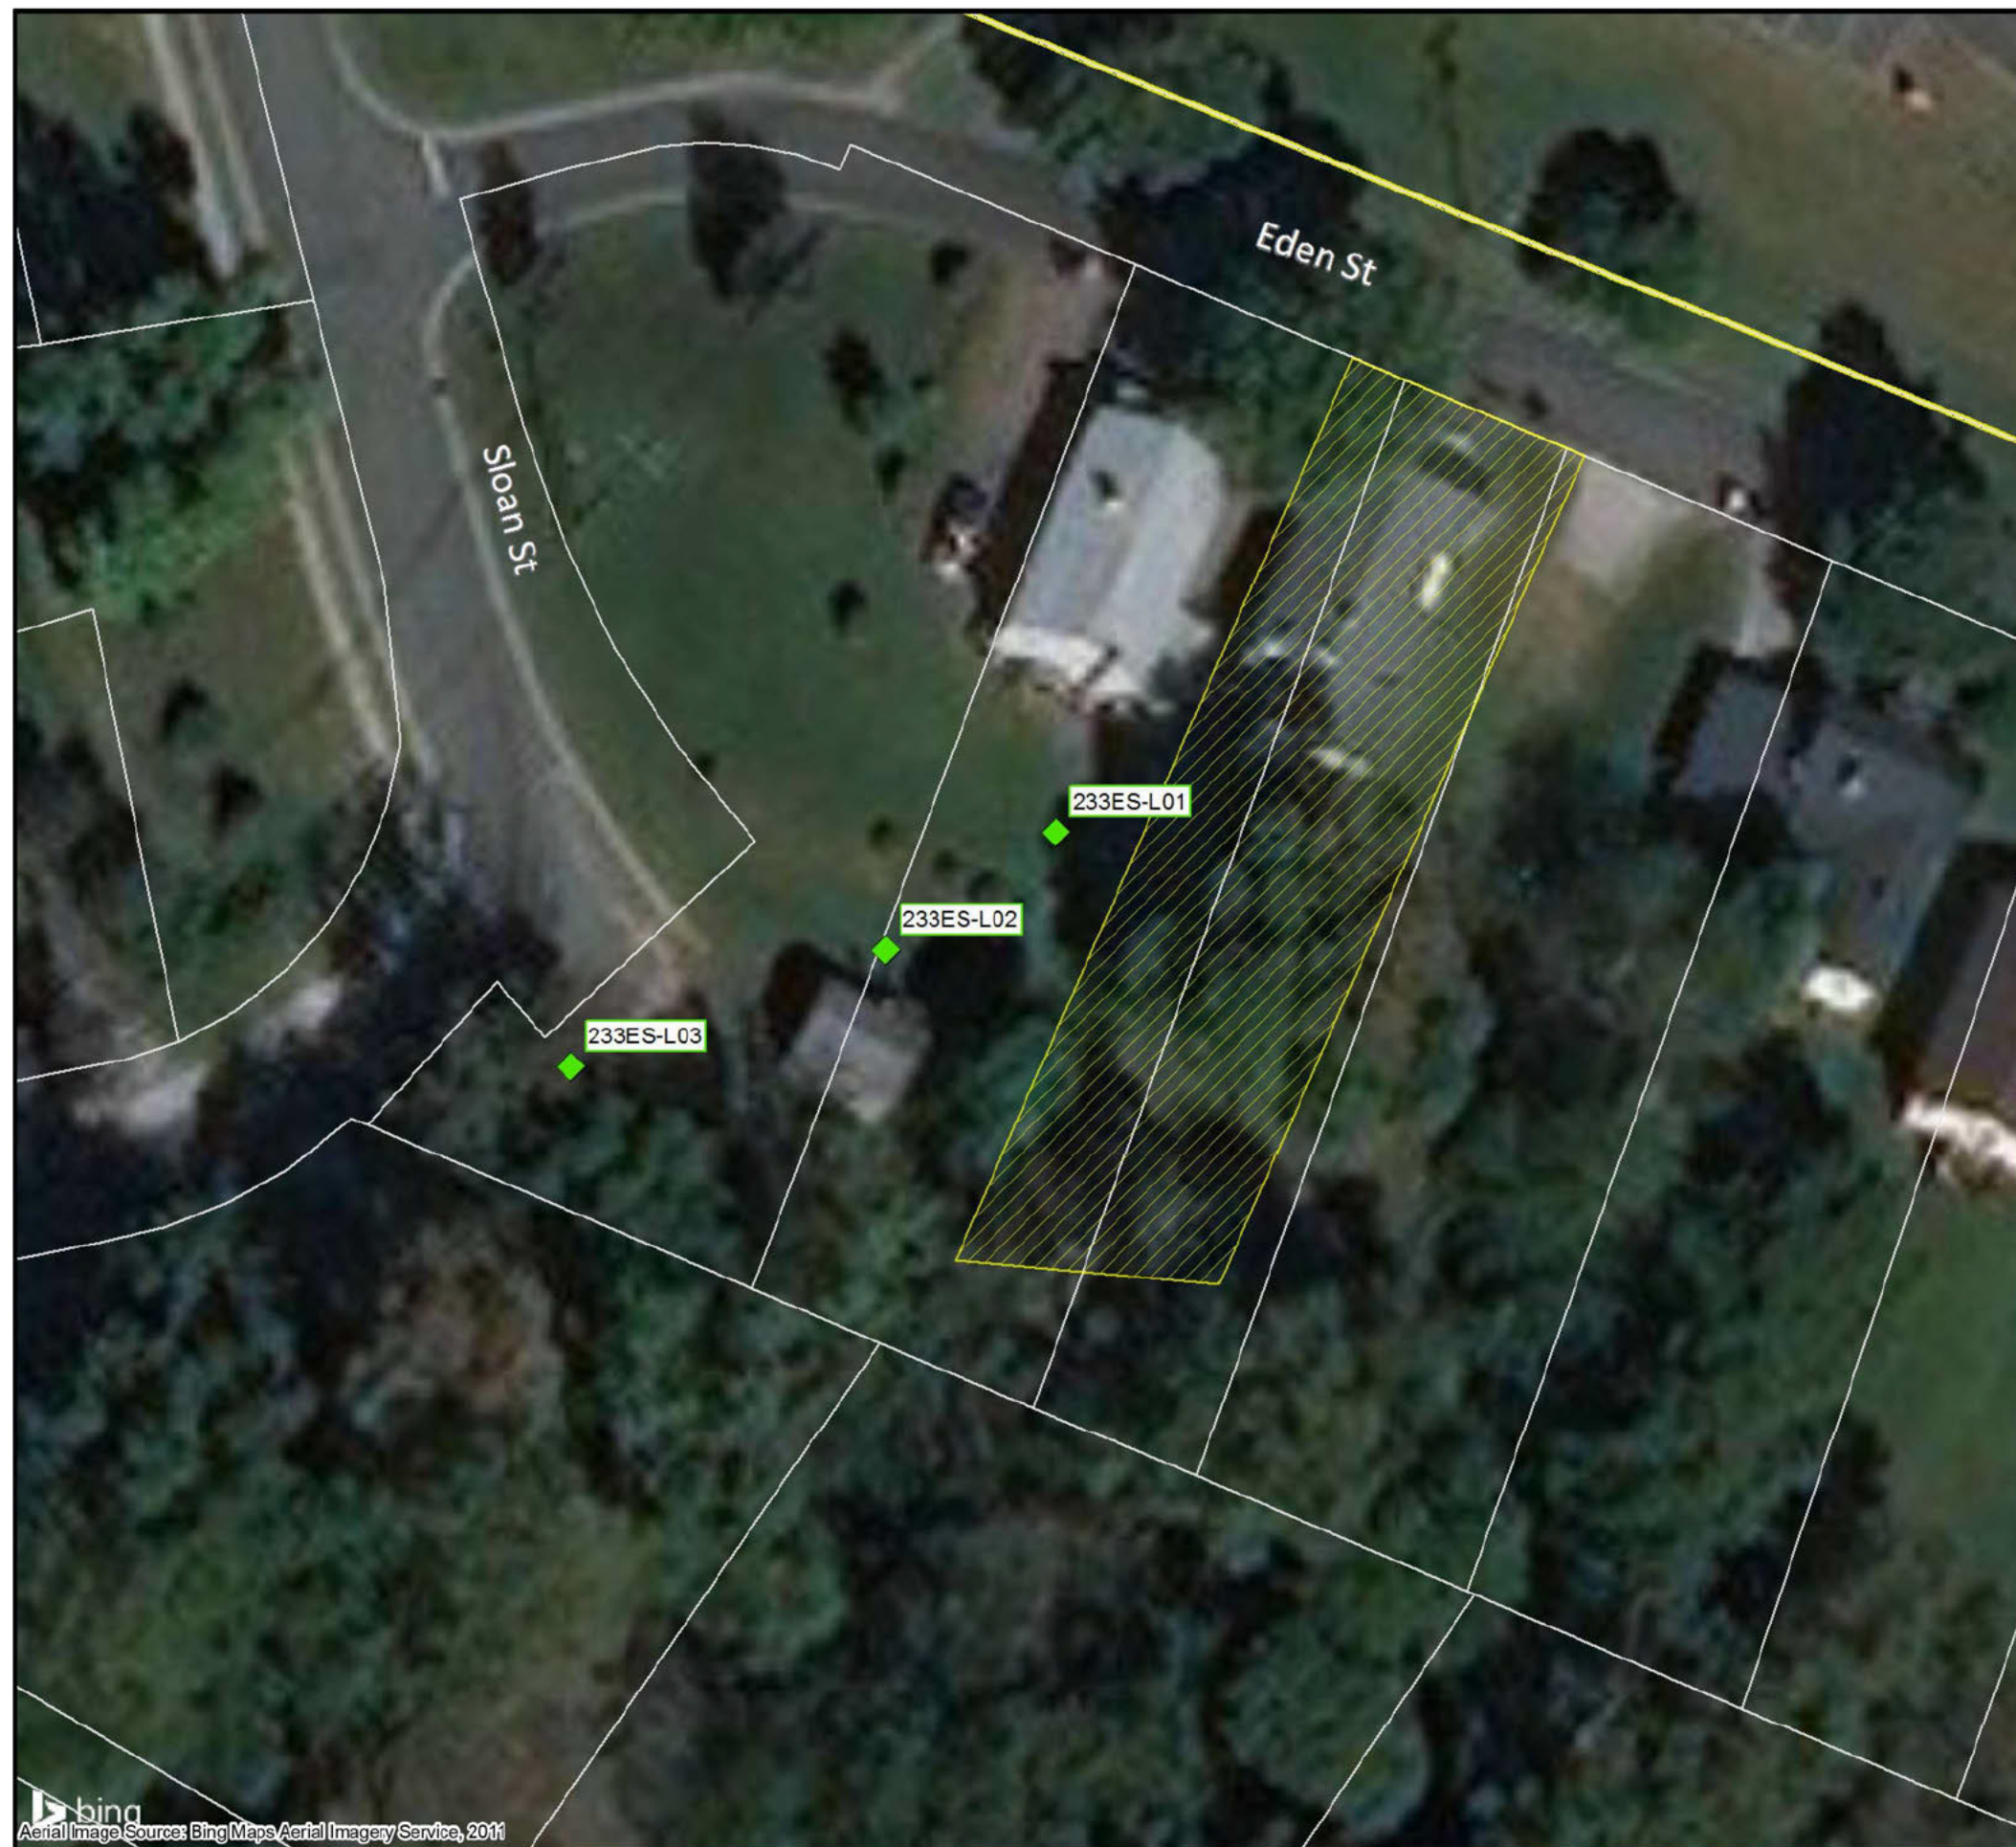
FIGURE 1

Removal Areas and
Air Sampling Locations

Description of Removal Action: The soil was excavated to an approximate maximum depth in the following areas: lawn to 24 inches; northern front yard area to 6 inches; and, along the residential foundation and tree and shrub line areas to 3 inches (see Appendix 1). Visual inspections of the areas excavated for asbestos-containing materials (ACM) were conducted by a State of North Carolina-accredited asbestos inspector and air monitor. Additional soil was removed in those areas where ACM were still visibly present, except along the base of the driveway and the street to prevent destabilization of their foundations. Once ACM was no longer visibly present throughout the main portion of the excavated area, restoration was allowed to commence. The visible, remaining ACM was photographed and documented in the site logbook prior to the commencement of restoration activities. In addition, ACM and asbestos-contaminated soil was removed to a depth of 1 inch from the underneath the southern end of the residence using hand tools.

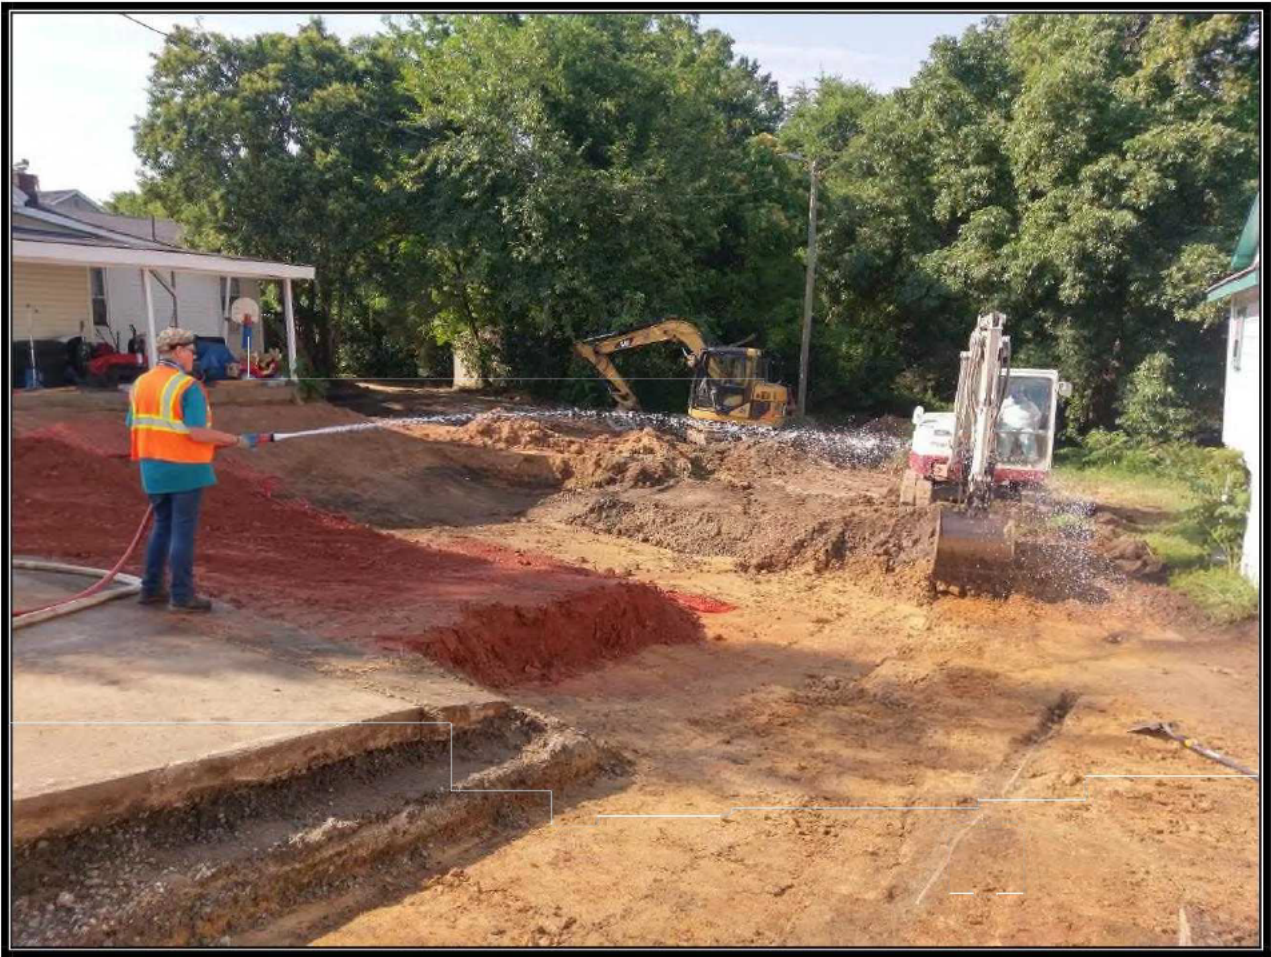
OFFICIAL PHOTOGRAPH NO. 1
U.S. ENVIRONMENTAL PROTECTION AGENCY

Subject: The Emergency and Rapid Response Services (ERRS) contractor, Environmental Restoration, LLC (ER), used an excavator and hand tools to remove asbestos-containing materials (ACM) and asbestos-contaminated soil from the property located at 233 Eden Street. ER used hoses to wet the asbestos-contaminated soil during removal activities.

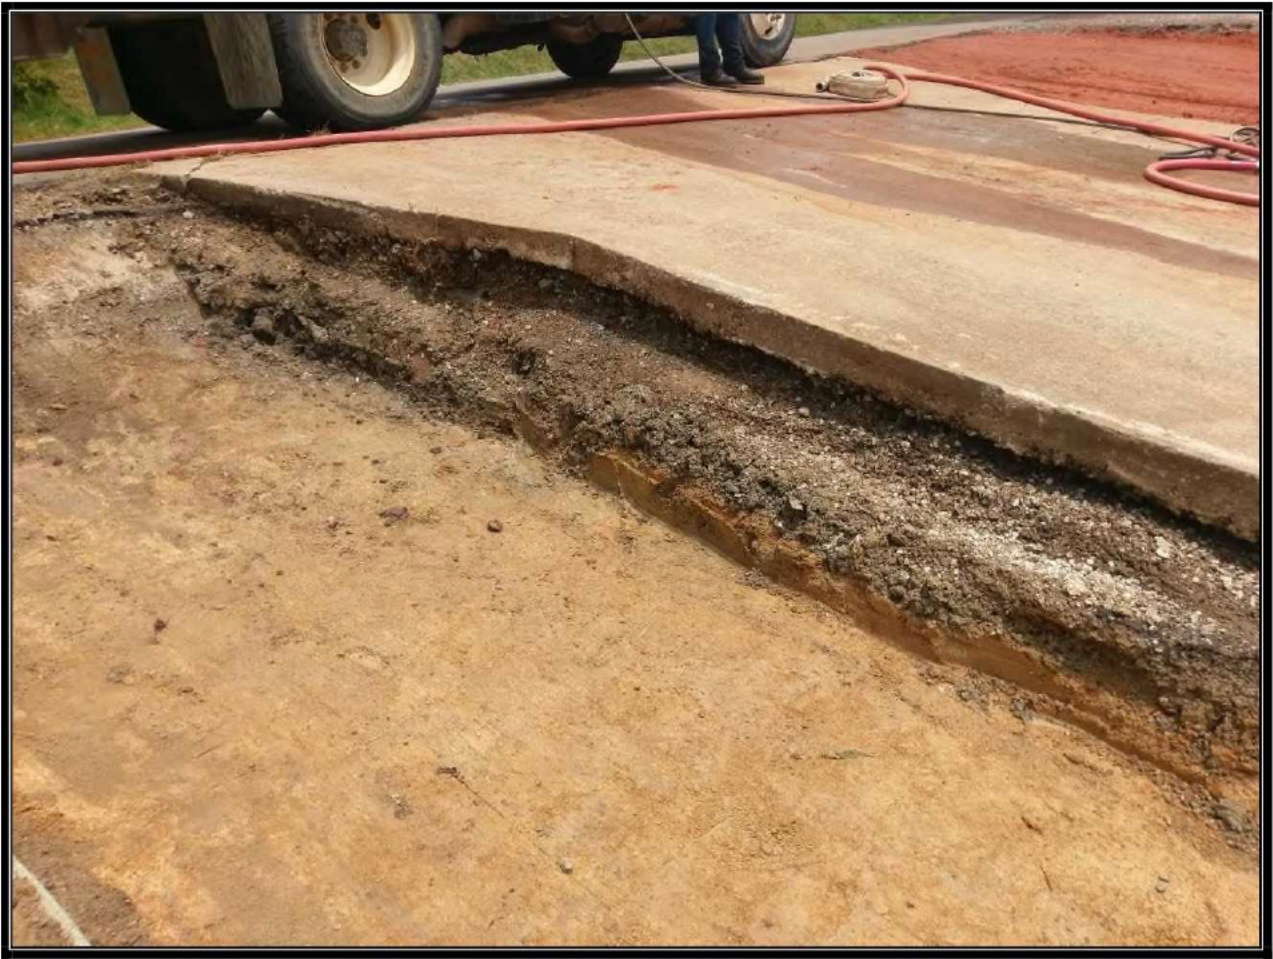
OFFICIAL PHOTOGRAPH NO. 4
U.S. ENVIRONMENTAL PROTECTION AGENCY

Subject: A Tetra Tech Superfund Technical Assessment and Response Team (START), State of North Carolina-accredited asbestos inspector and air monitor, visually inspected the excavated areas for the presence of visible ACM. ER removed additional soil in those areas where ACM were still visibly present, except along the base of the driveway and the street to prevent destabilization of their foundations.

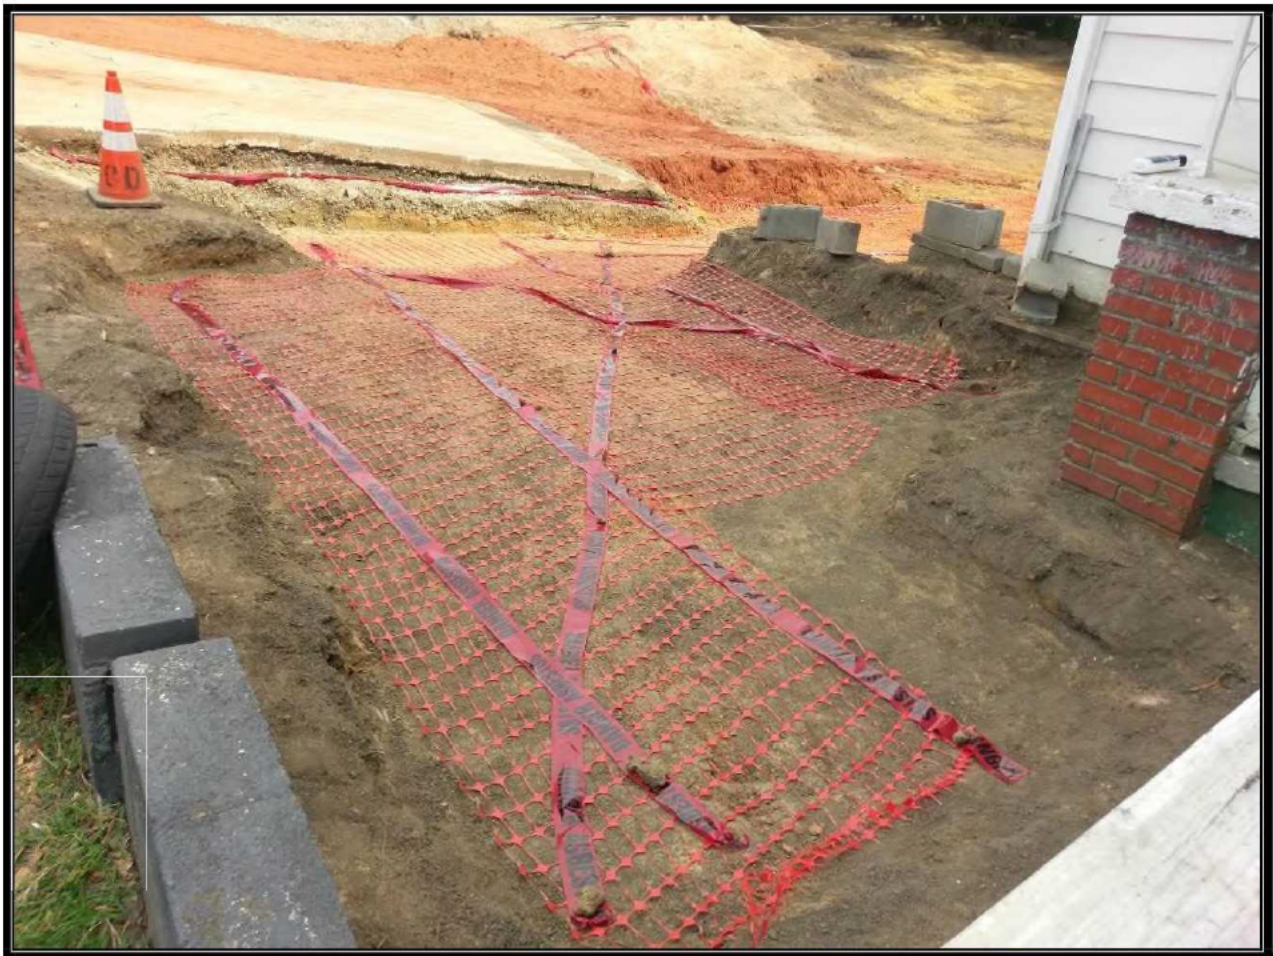
OFFICIAL PHOTOGRAPH NO. 3
U.S. ENVIRONMENTAL PROTECTION AGENCY

Subject: ER installed snow fencing and red "Danger Asbestos" tape along the subsurface of the excavated area to identify the depth of the excavation and the presence of ACM after the visual inspection, conducted by Tetra Tech START, State of North Carolina-accredited asbestos inspector and air monitor, was completed.

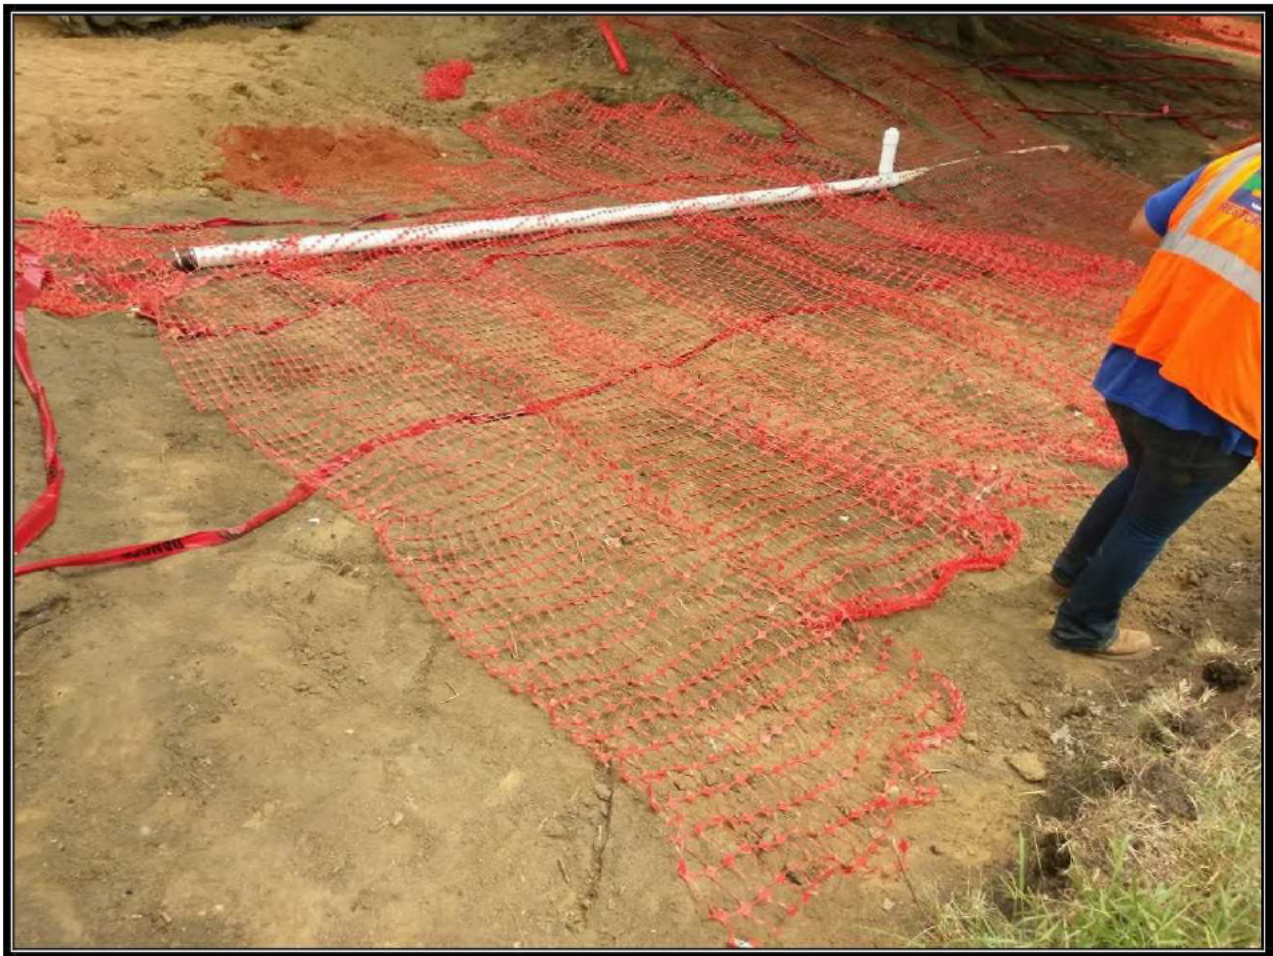
OFFICIAL PHOTOGRAPH NO. 4
U.S. ENVIRONMENTAL PROTECTION AGENCY

Subject: ER installed snow fencing and red "Danger Asbestos" tape along the subsurface of the excavated area to identify the depth of the excavation and the presence of ACM after the visual inspection, conducted by Tetra Tech START, State of North Carolina-accredited asbestos inspector and air monitor, was completed. ER also replaced a section of the sewage line located in the back yard.

Restoration of Property: Restoration work included installation of snow fencing and red "Danger Asbestos" tape on top of the subsurface of the excavated area, backfill, topsoil, and sod in the excavated lawn areas, topsoil and sod in the northern front yard area, and topsoil and mulch around the tree and shrub lines. All areas were restored to the original height of the surrounding grade. Furthermore, a section of sewage pipe approximately 20 feet long was replaced in the back yard.

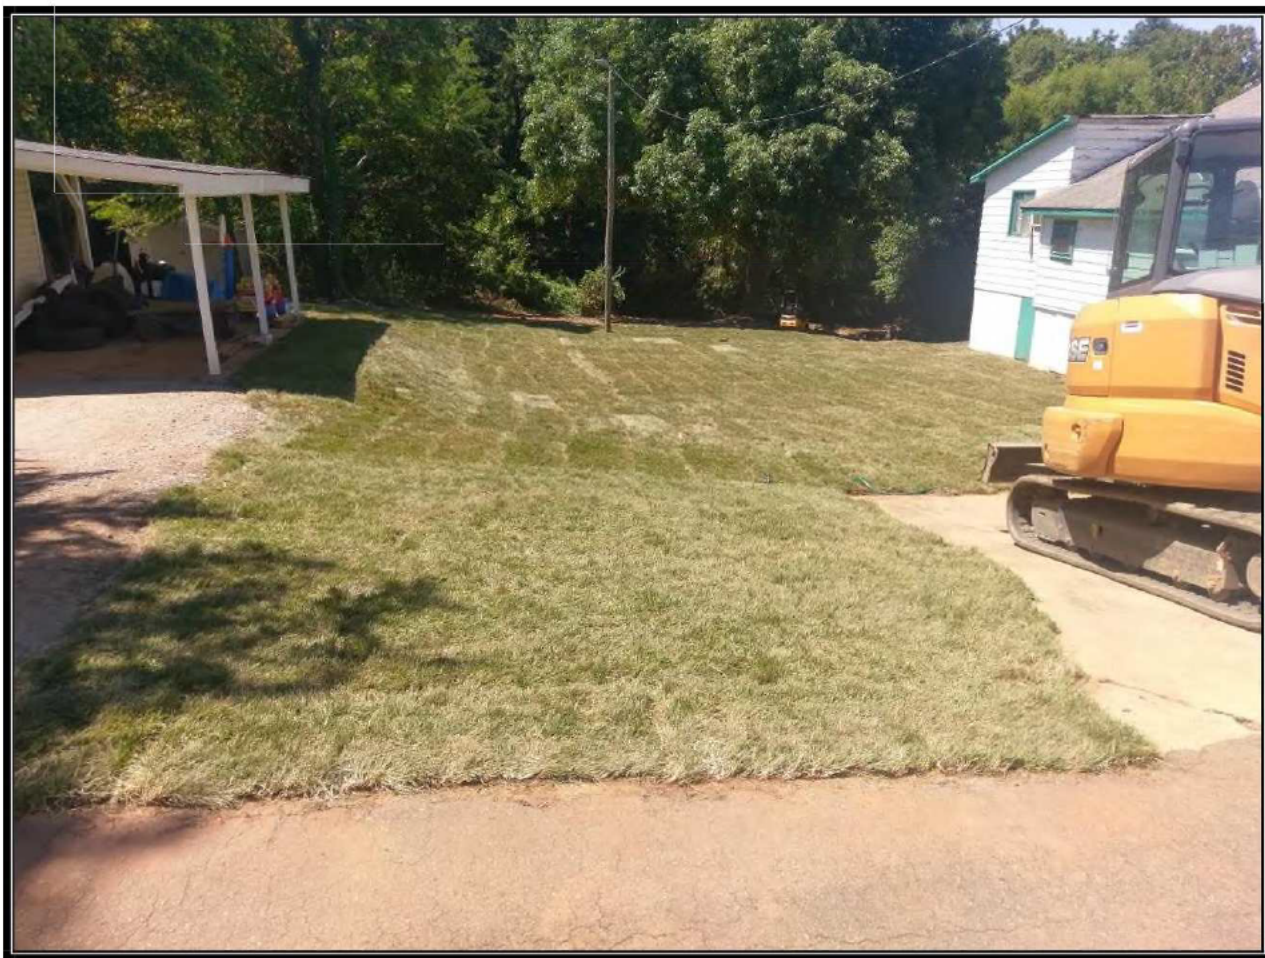
OFFICIAL PHOTOGRAPH NO. 5
U.S. ENVIRONMENTAL PROTECTION AGENCY

Subject: ER installed sod in the excavated areas after backfill and topsoil were in place.

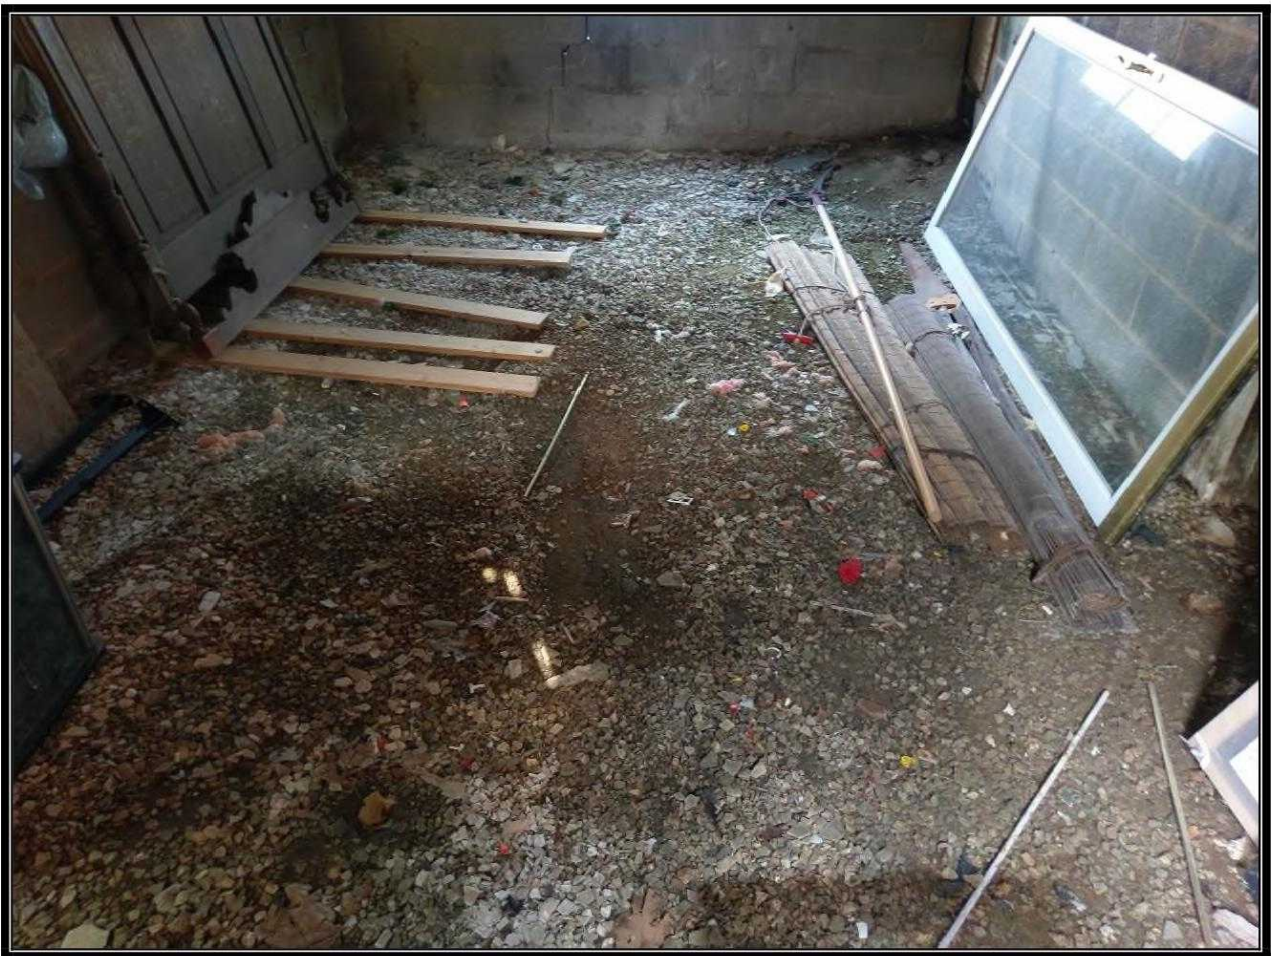
OFFICIAL PHOTOGRAPH NO. 6
U.S. ENVIRONMENTAL PROTECTION AGENCY

TDD Number:	TT-01-071	Location:	Davidson Asbestos
Orientation:	Not applicable	Date:	July 27, 2017
Photographer:	Paul Prys, Tetra Tech	Witness:	None
Subject:	ACM and asbestos-contaminated soil were detected underneath the southern end of the residence.

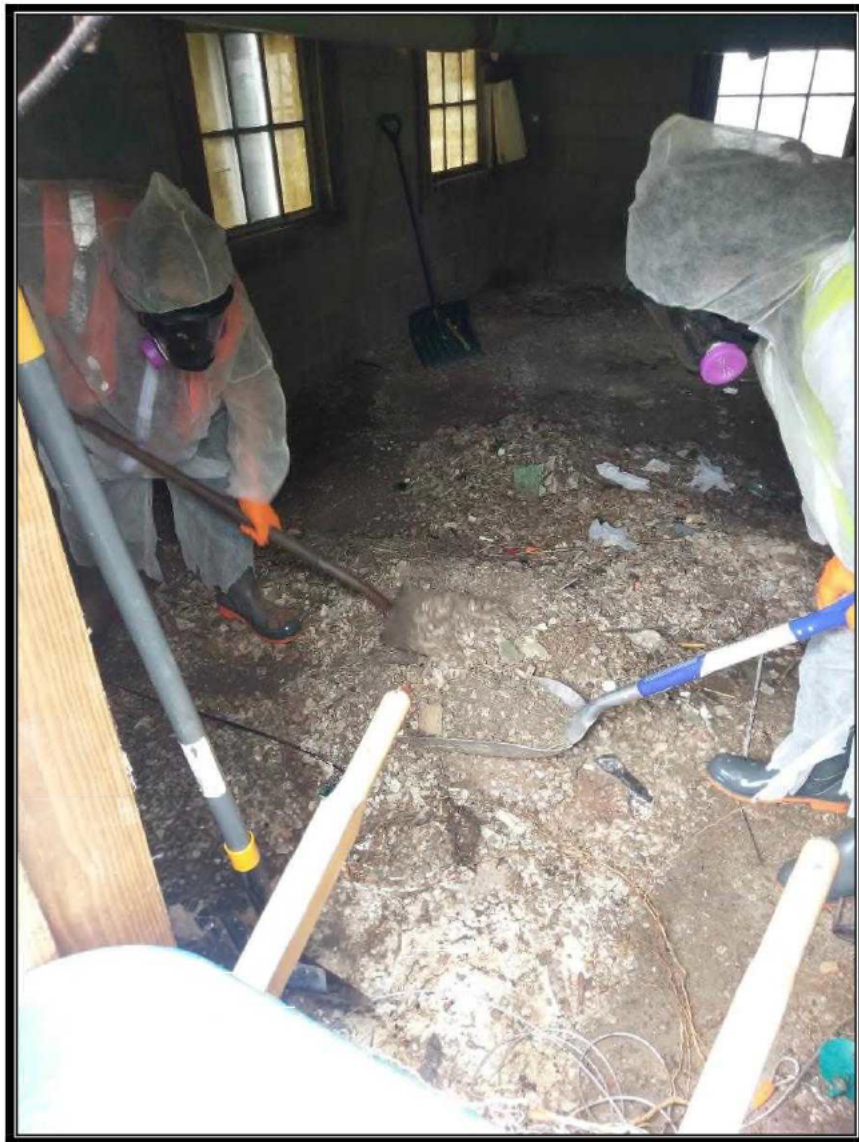
OFFICIAL PHOTOGRAPH NO. 7
U.S. ENVIRONMENTAL PROTECTION AGENCY

Subject: ER used hand tools to remove ACM and asbestos-contaminated soil from underneath the southern end of the residence.

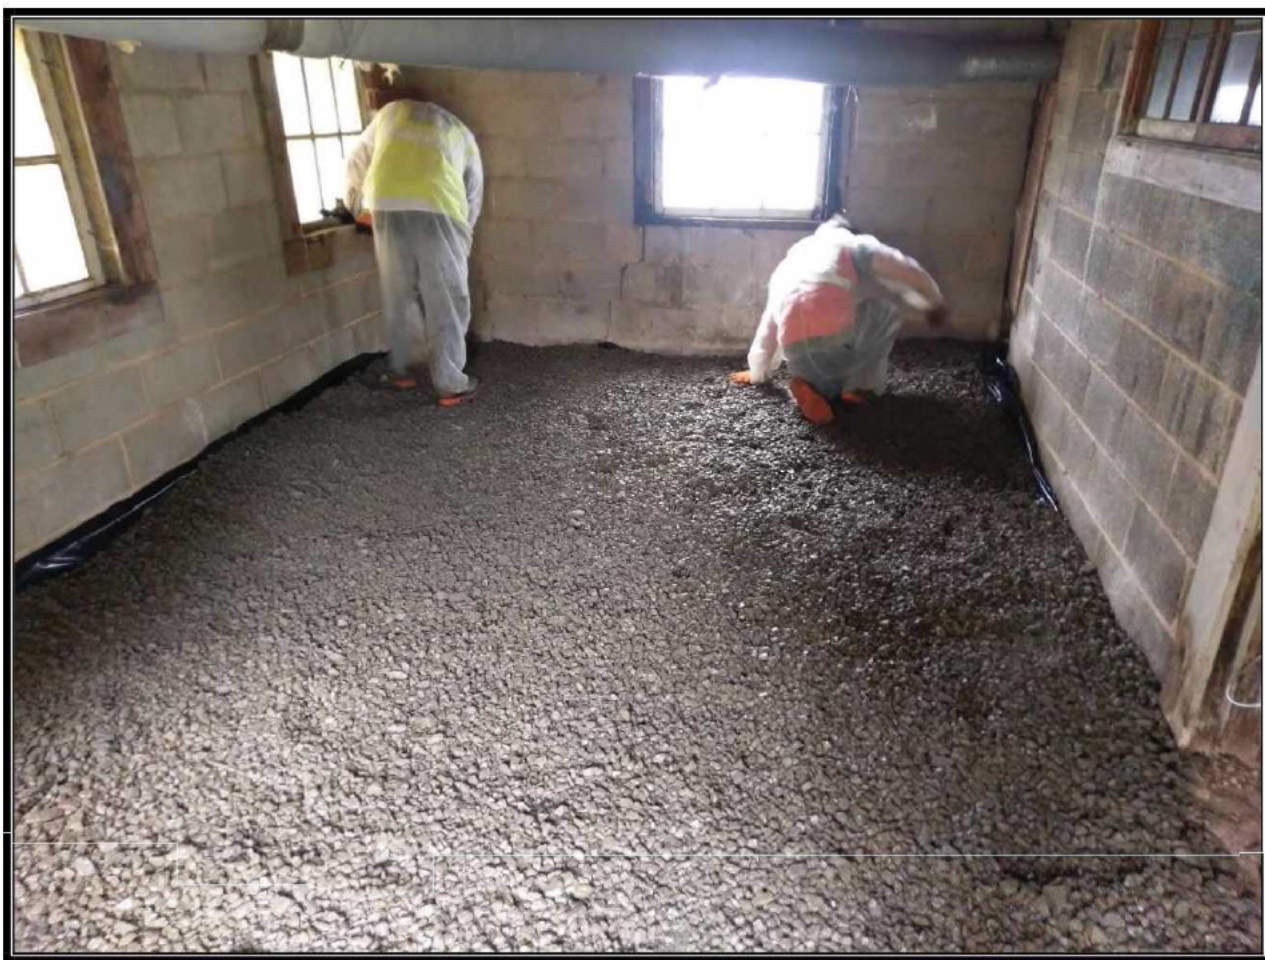
OFFICIAL PHOTOGRAPH NO. 8
U.S. ENVIRONMENTAL PROTECTION AGENCY

Subject: ER installed breathable plastic sheeting and rock over the floor underneath the southern end of the residence after a Tetra Tech START, State of North Carolina-accredited asbestos inspector and air monitor, visually inspected the area and did not detect the presence of visible ACM.
